SURFACE CRACK GROWTH IN FIBER COMPOSITES

J. Im, J.F. Mandell, S.S. Wang, and F.J. McGarry

MASSACHUSETTS INSTITUTE OF TECHNOLOGY

(NASA-CR-135094) SURFACE CRACK GROWTH IN
FIBER COMPOSITES Interim Report, 1 Feb.
1975 - 1 May 1976 (Massachusetts Inst. of
Tech.) 134 F HC A07/MF A01 CSCI 11D

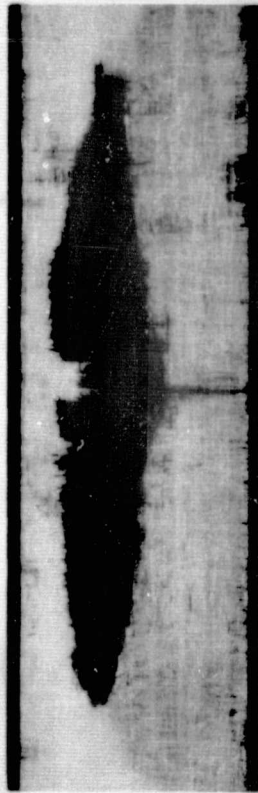
FIGURE 37.

SHAPE OF CRACK TIP DELAMINATION AT
INTERFACE (3-4), 90/0 (15 LAYERS), 1002
SCOTCHPLY WITH SURFACE CRACK.
